LEHIGH RIVER BASIN,
POHOPOCO CREEK, PENNSYLVANIA .

BELTZVILLE LAKE.

CONDITION REPORT. DAM, OUTLET WORKS & SPILLWAY PERIODIC INSPECTION REPORT, NO. 1,

JULY 1970.

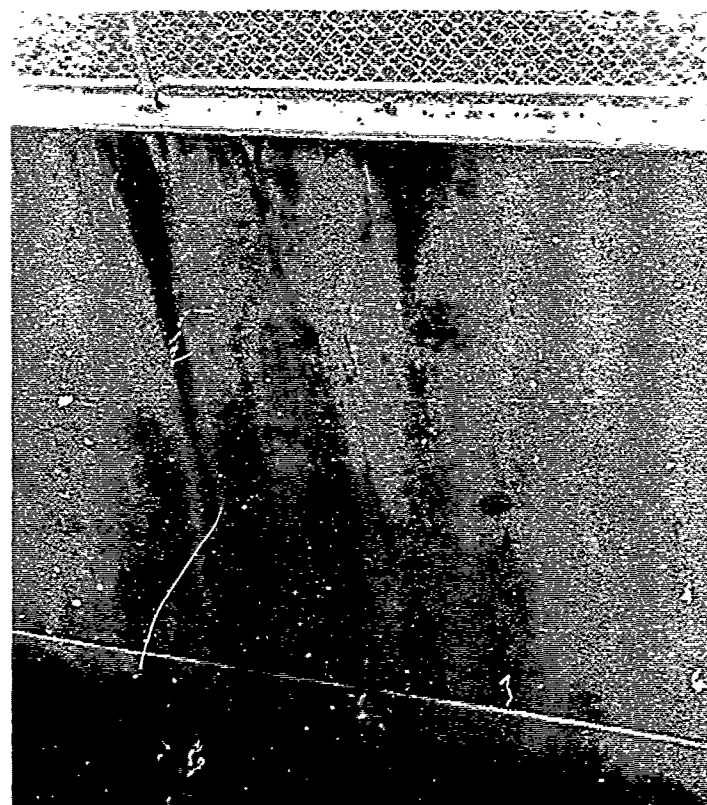
(2) Stilling basin walls: Photographs 4 and 5 show a minor crack and a joint spall in the left basin wall. No repair needed.

Photo No. 4 Minor crack in left wing wall -
outlet works.

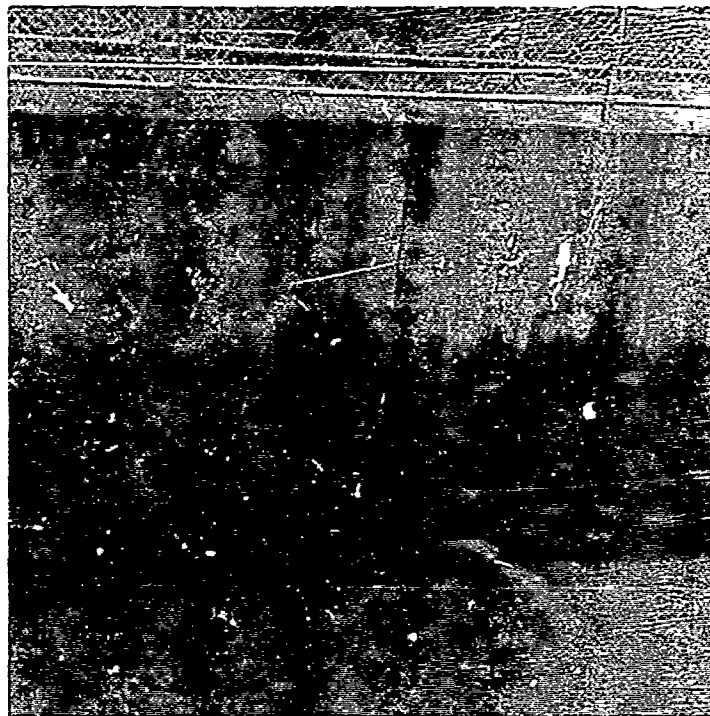
Photo No. 5 Minor joint spall in left wing
wall - outlet works.

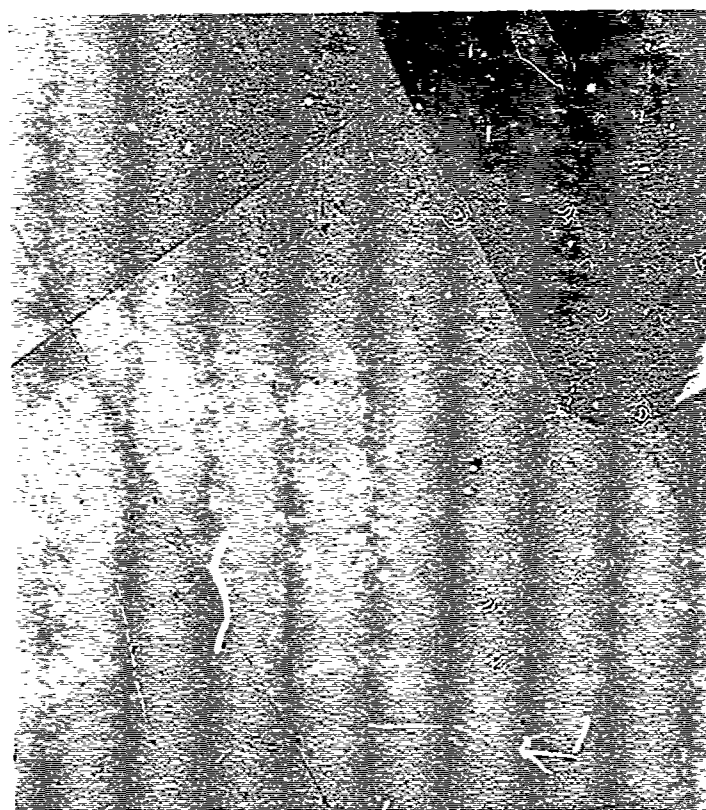
(3) Cracks: Many hairline cracks have appeared in the surface of the spillway slab. The majority, however, are minor in nature. One crack is a working crack and will be sealed. Photographs 12, 13 and 14 show, in general, the surface cracks. Photographs 15 and 16 show the working crack.

Photo No. 12 Cracks in spillway slab.

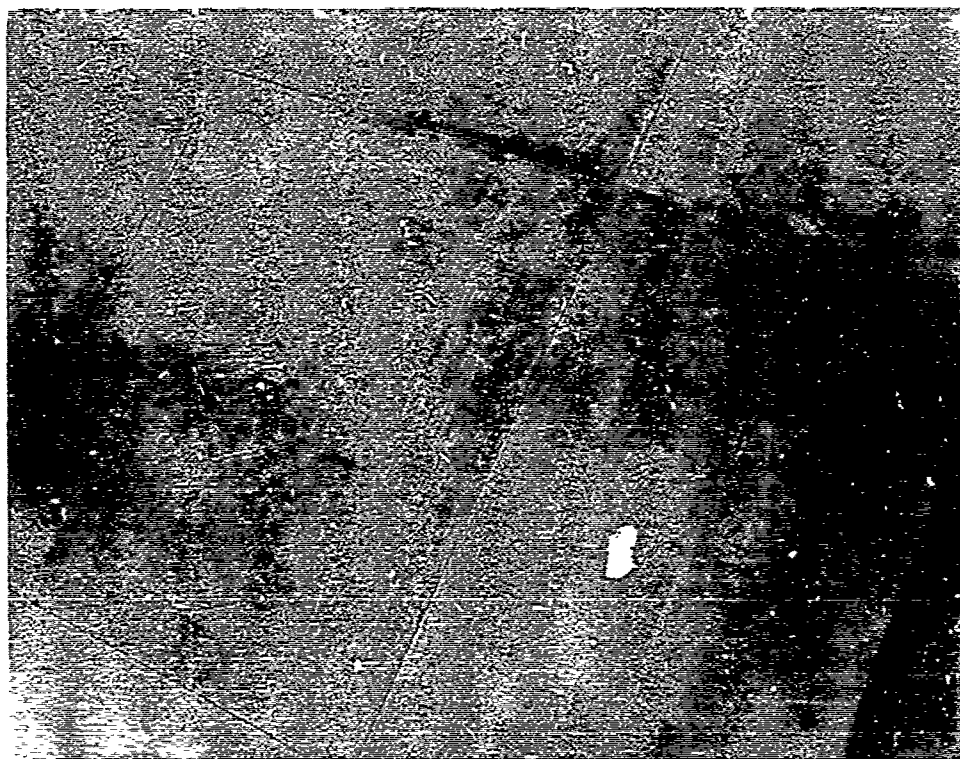
Photo No. 13 Cracks in spillway slab.

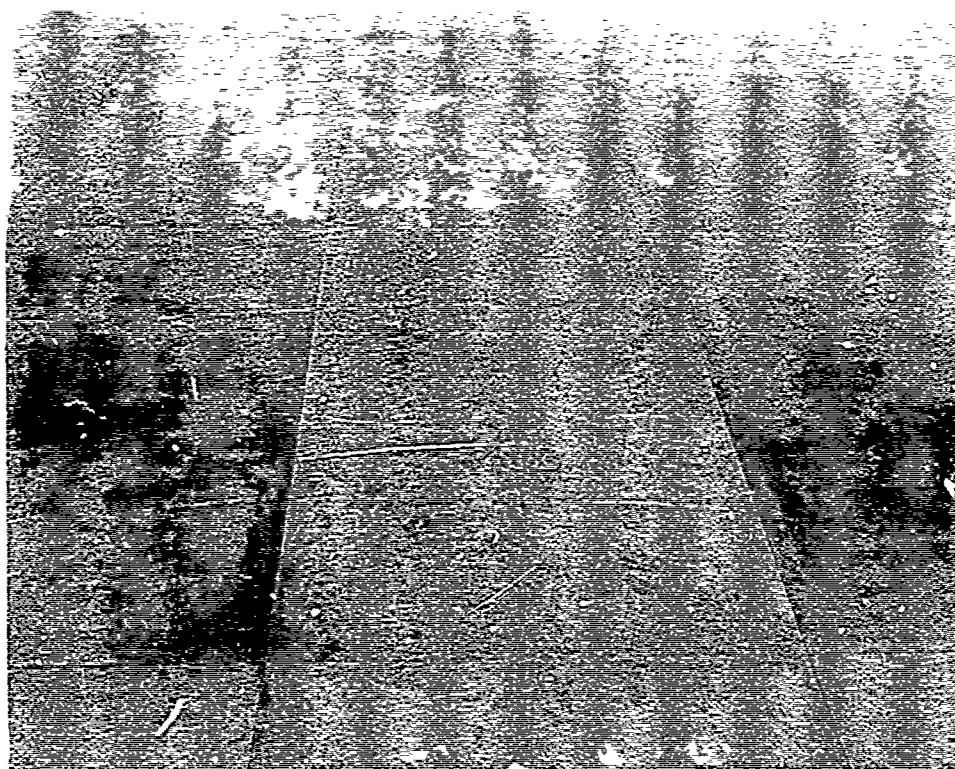
Photo No. 14 Cracks in spillway slab.

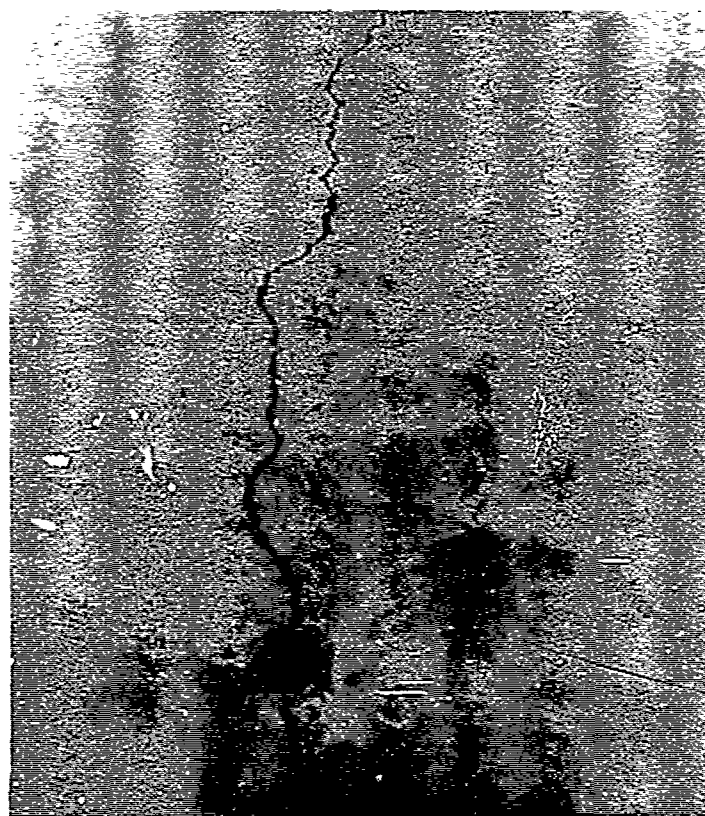
(1) Concrete surface: Surface of spillway slab is rough with poor finish, has appearance of over-sanded mix or coarse grout covering. Many hairline cracks appear in surface of slabs. One working crack will progressively become worse after several freeze-thaw cycles and should be sealed.

Photo No. 16 Working crack, spillway slab.

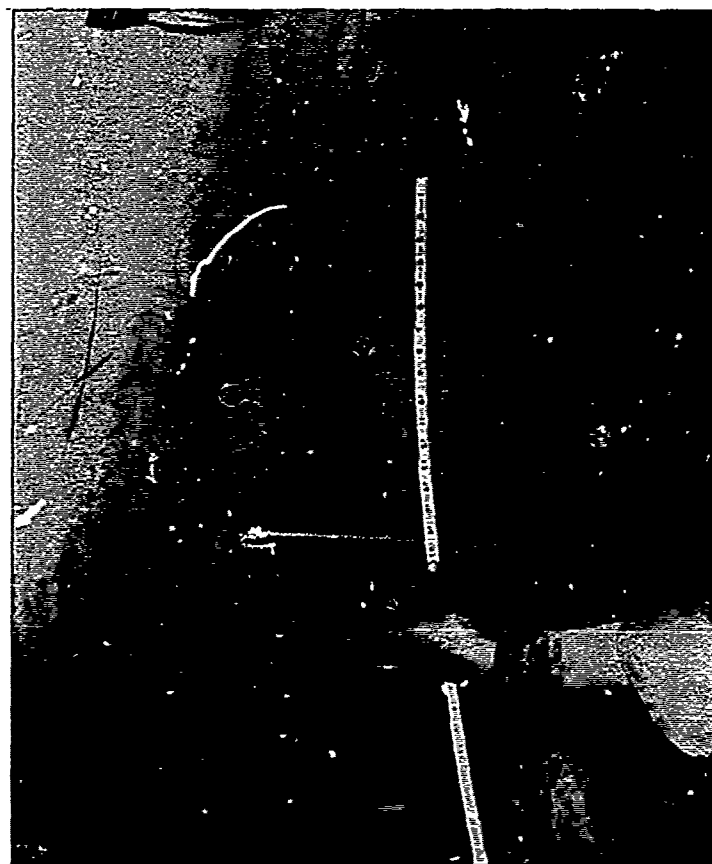
Photo No. A-1 Minor joint spall at
Sta. 9+44.

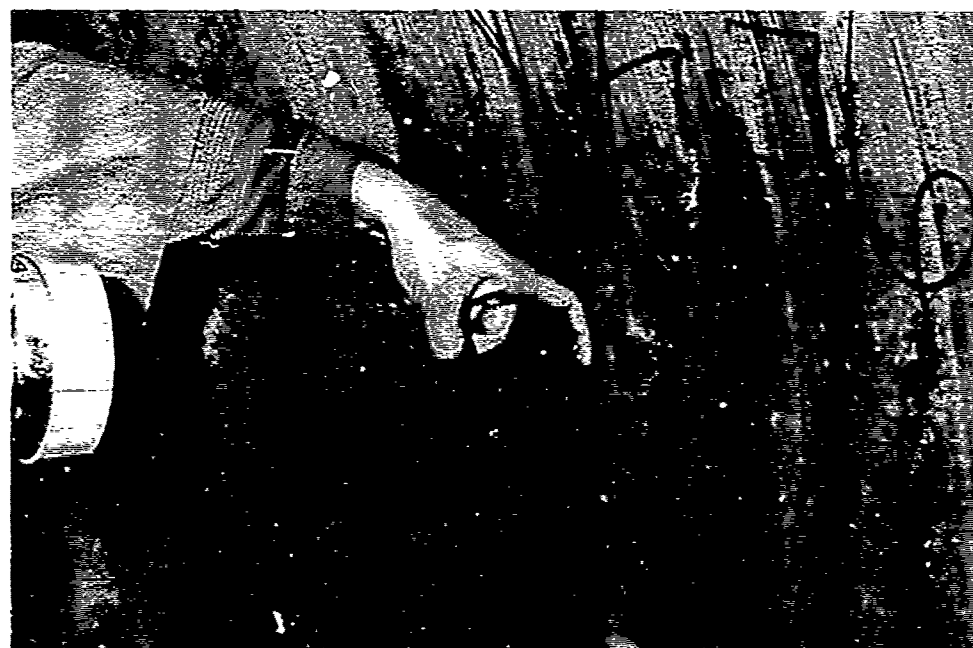
Photo No. A-2 Small air void at Sta. 7+76.

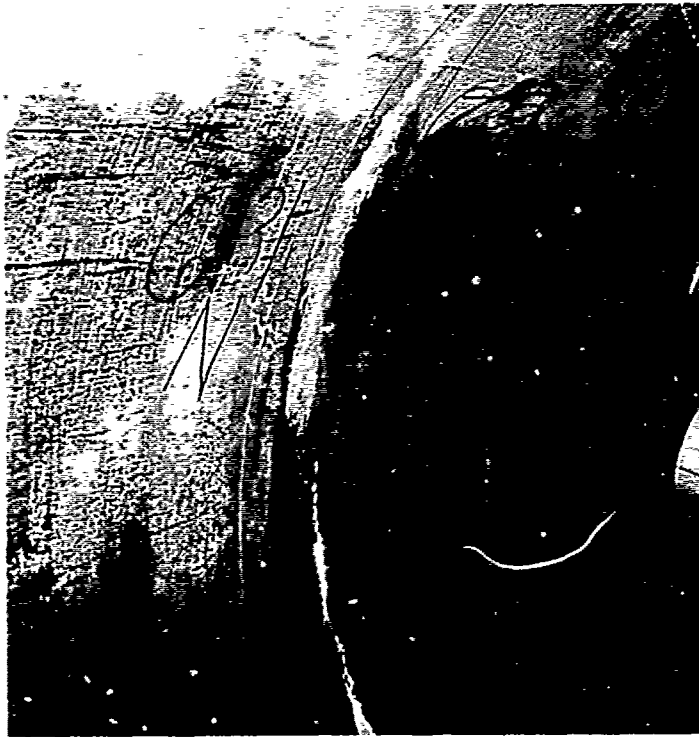
Photo No. A-3 Crack sealed by calcium
deposits at Sta. 6+31.

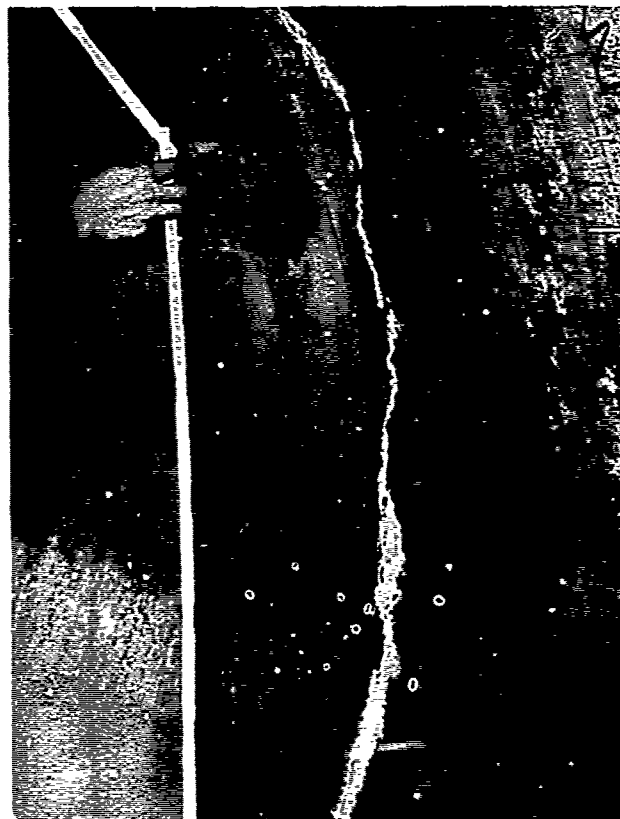
Photo No. A-4 Crack sealed by calcium
deposits at Sta. 6+25.

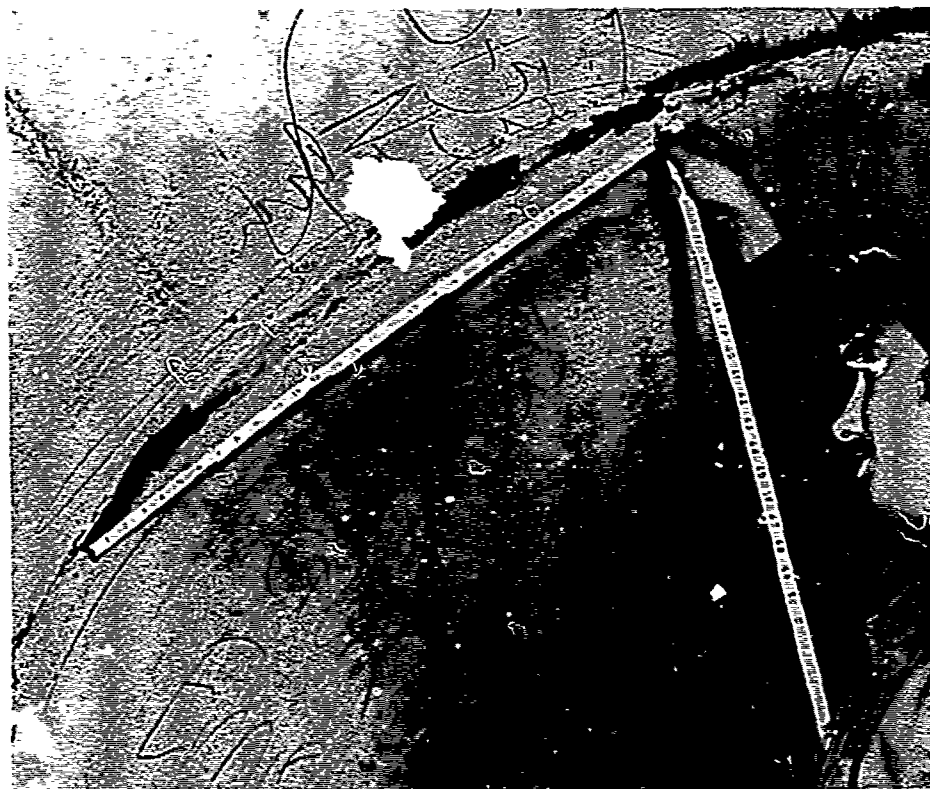
Photo No. A-6 Minor joint spall at
Sta. 5+53.

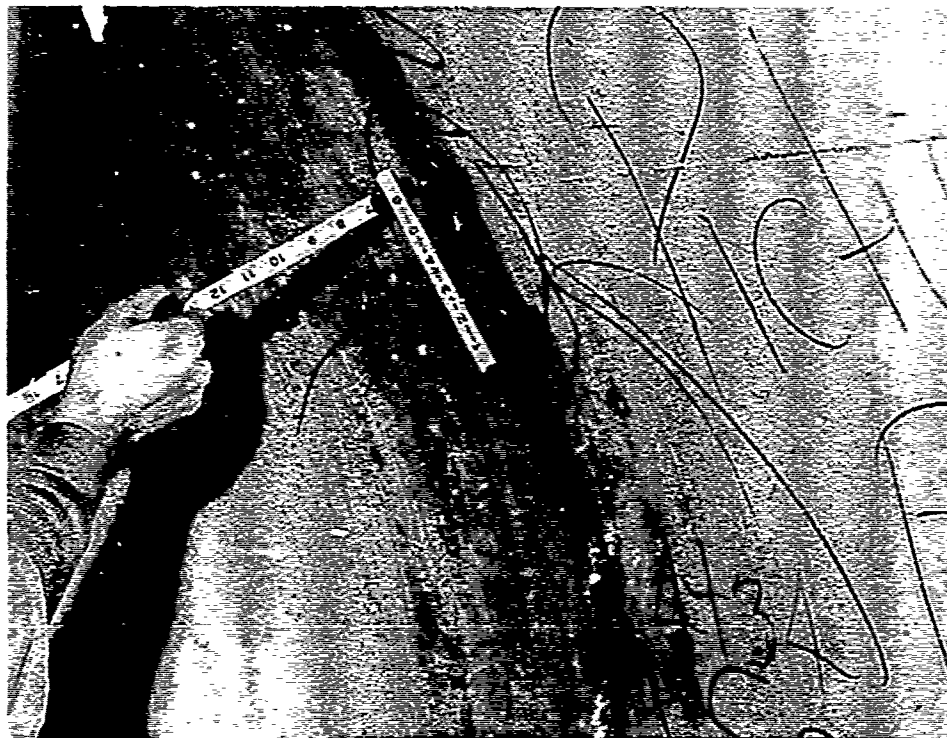
Photo No. A-7 Minor joint spall at
Sta. 4+43.

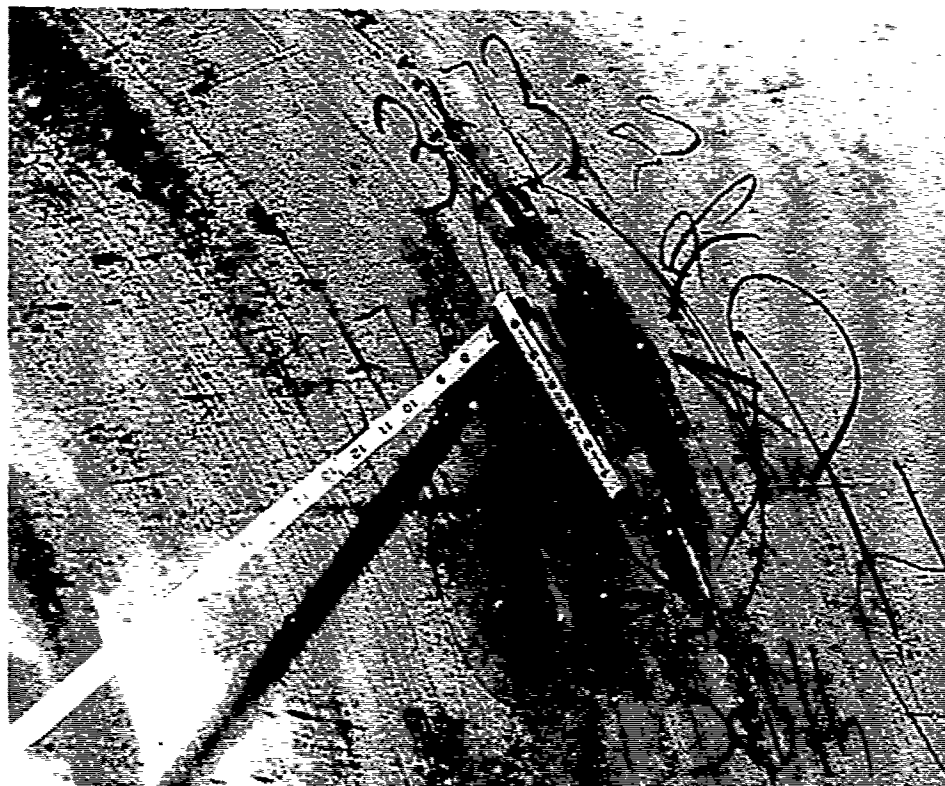
Photo No. A-8 Minor joint spall at
Sta. 3+73.

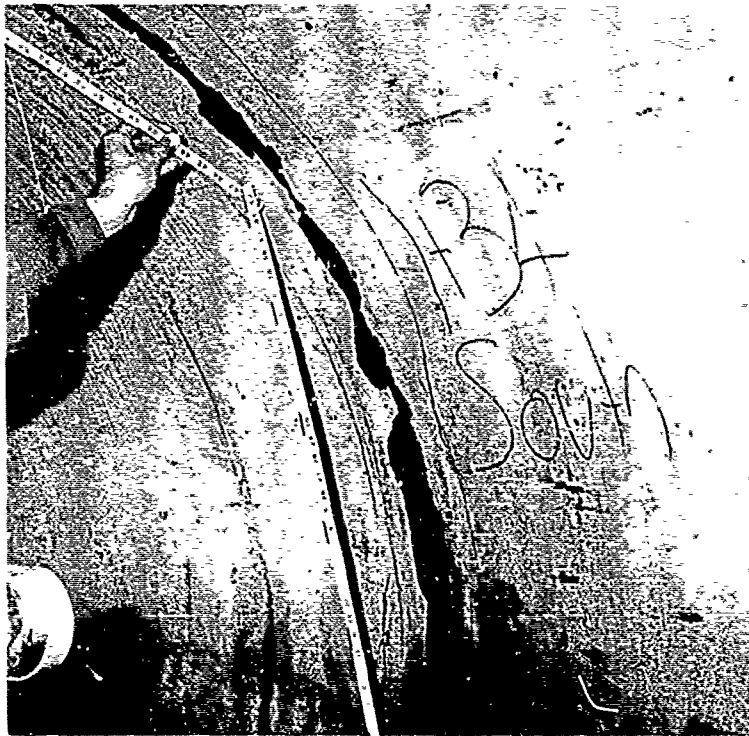
Photo No. A-11 Minor joint spall at
Sta. 1+34.

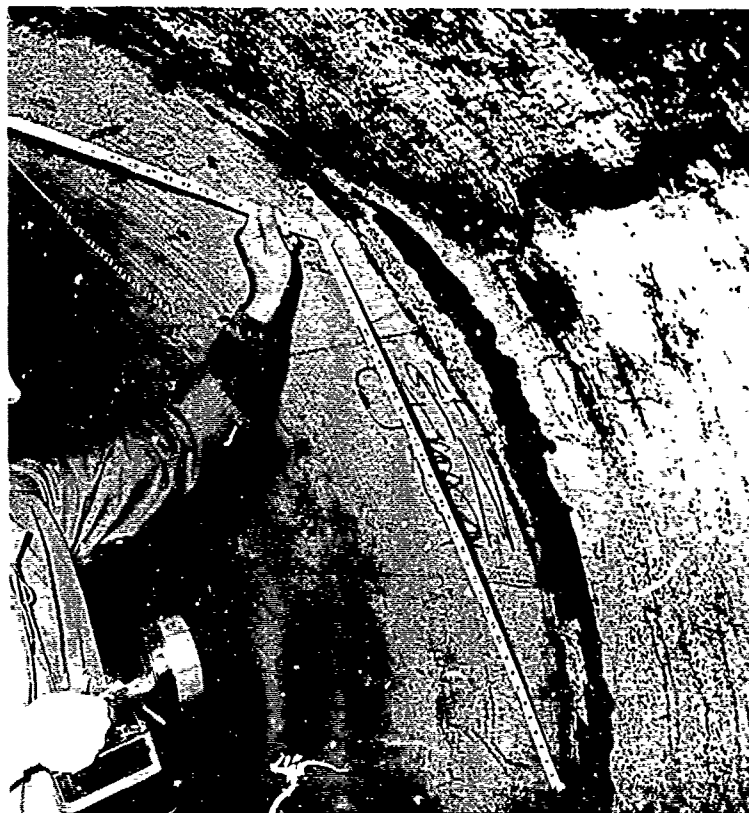
Photo No. A-12 Minor joint spall at
Sta. 0+94.

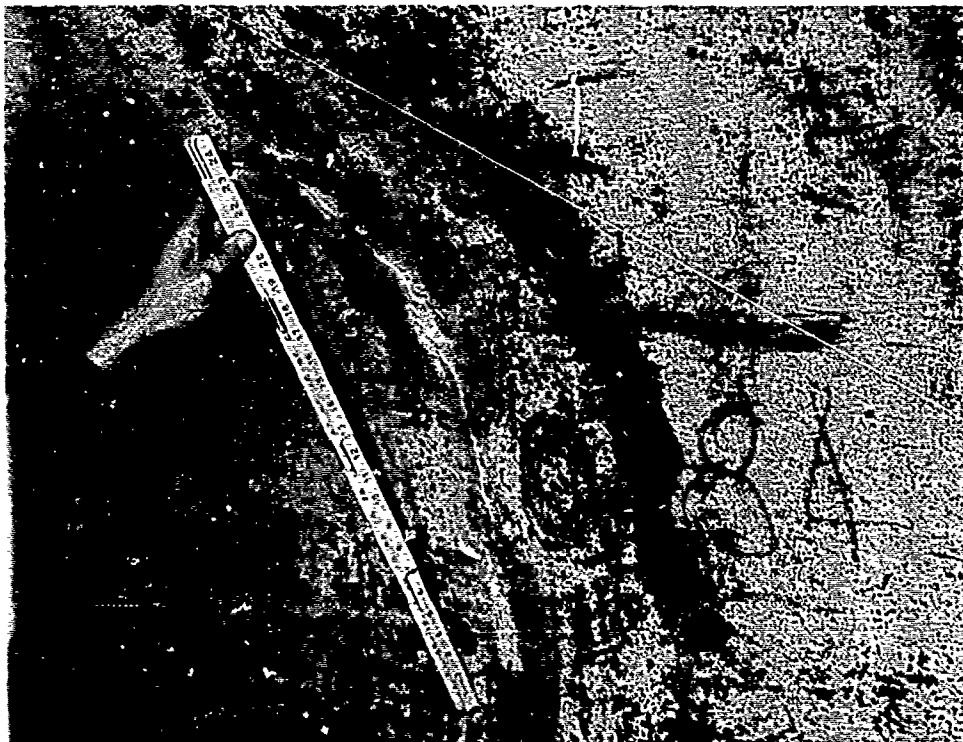
Photo No. A-13 Minor crack sealed by calcium
deposits at Sta. 0+84.

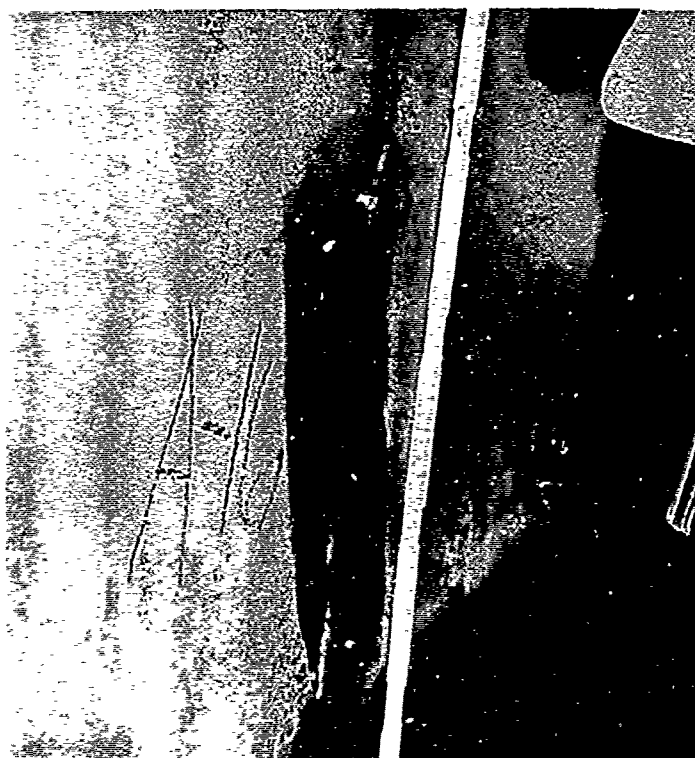
Photo No. A-16 Minor crack in South Chamber
with light seepage at
Sta. 0+43.

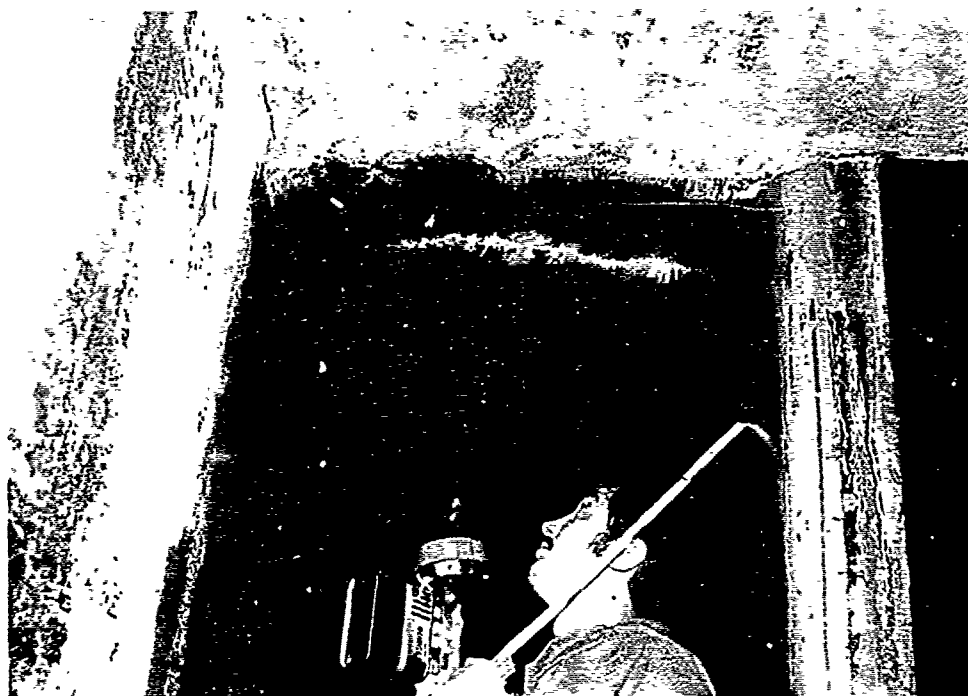
Photo No. B-3 Ceiling crack in North
Chamber at Sta. 0+67 sealed
by calcium deposits.

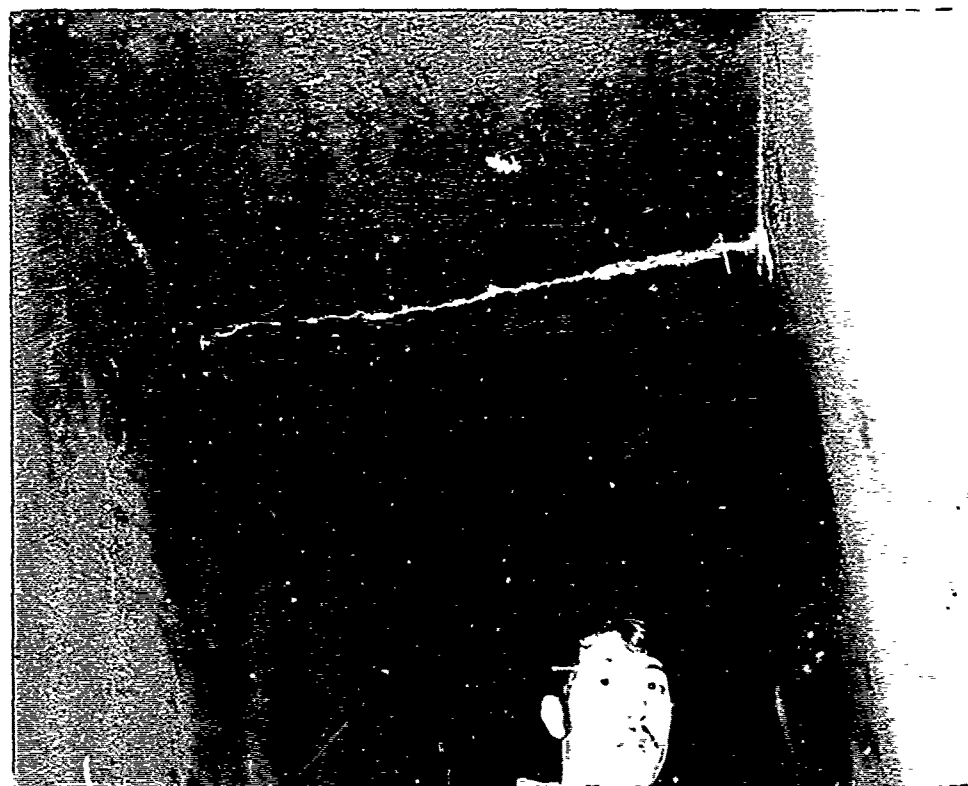
Photo No. B-4 Ceiling crack in North
Chamber at Sta. 0+58 sealed
by calcium deposits.

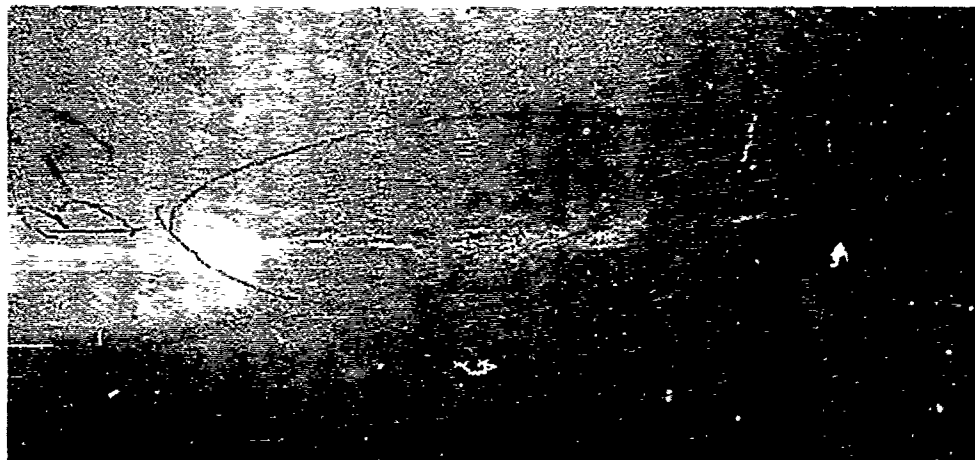
Photo No. B-5 Minor joint spall in wall of
North Chamber at Sta. 0+43.
